Caisson Repairs

IMG Offshore provide a full Caisson Rehabilitation Service. Whatever the problem:

A major Gas Storage Facility in the Southern North Sea had severe through wall perforation problems

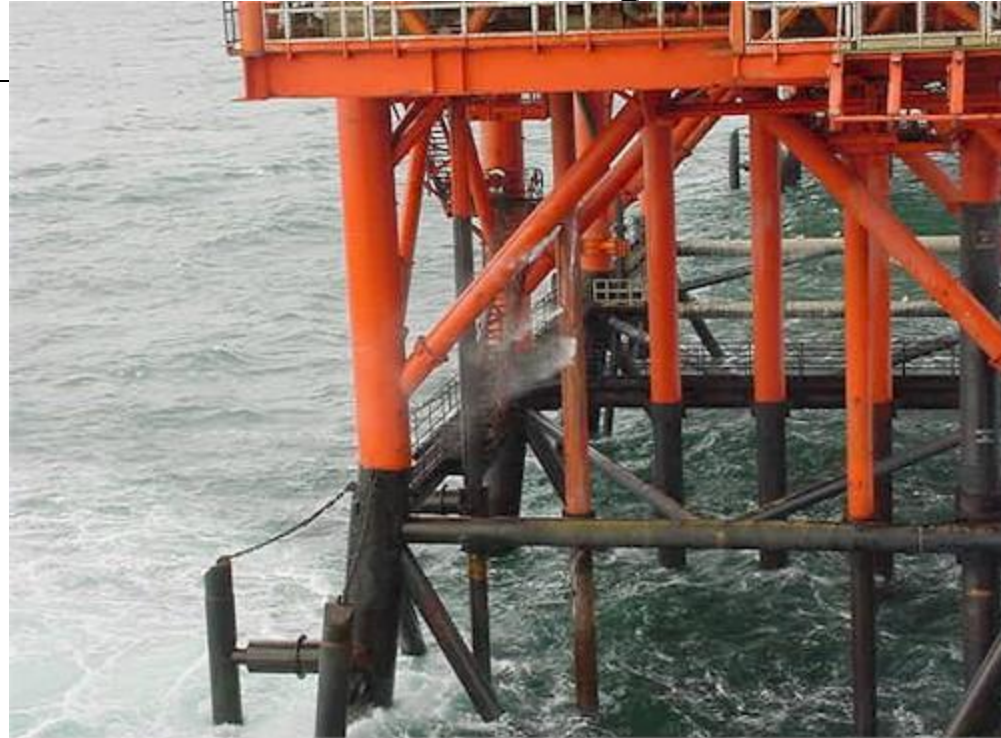
The Caisson had several clamps fitted to provide integrity, however leakage was still occurring below the clamps

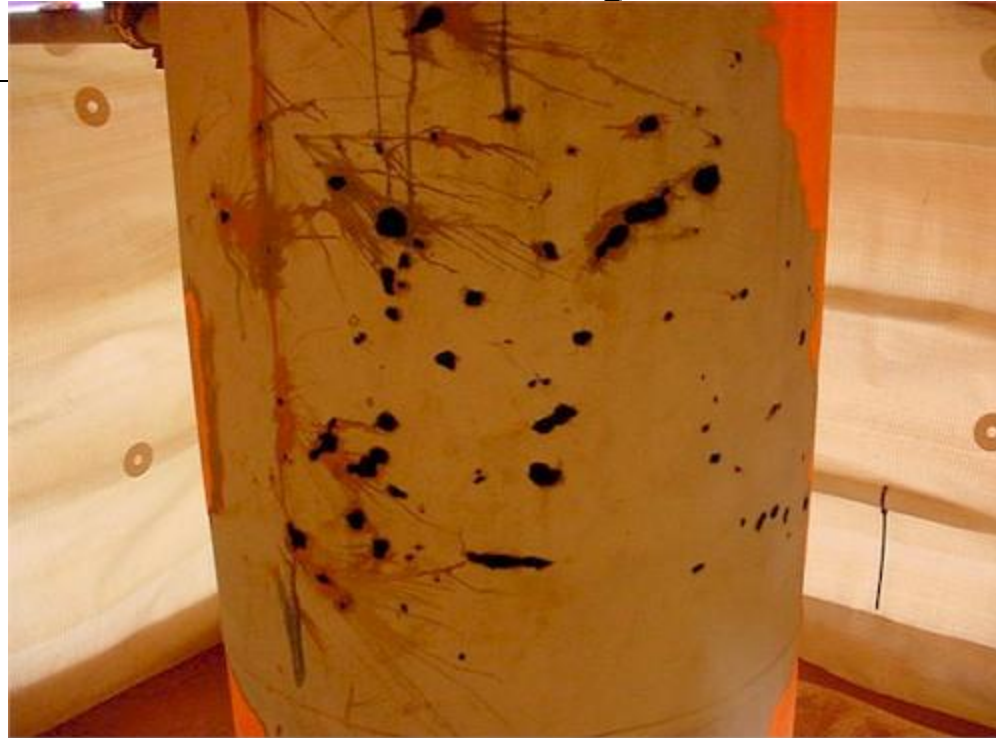
After removal of the clamps the full extent of the damage was evident. A total of 461 holes were found within a 15 metre section
